Project Short-Report/December 2019

Refurbishment Stormwater Basin: Permanent Durability of Concrete Structure

Municipal sewage plant, stormwater basin

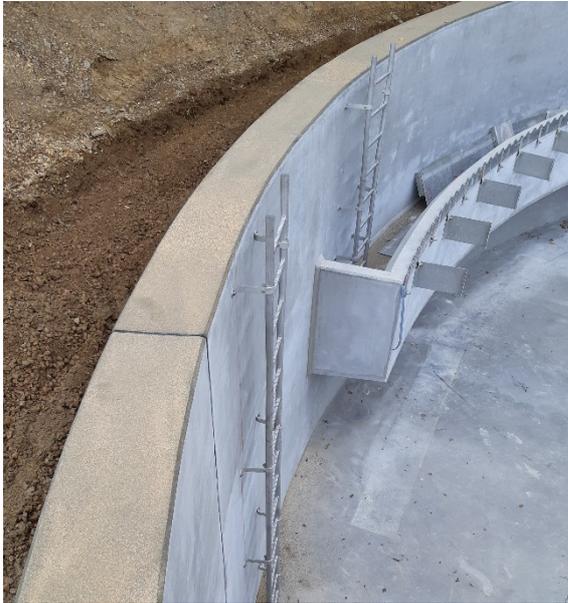
After a thorough analysis of the concrete damage, the substrate was prepared using high-pressure water jets. Exposed reinforcement received StoCrete TK corrosion protection to provide long-term protection against possible future corrosion of the reinforcing steel. Depending on the required layer thickness, the damaged areas were reprofiled using StoCrete TG 252 or StoCrete TG 254 on the afore applied bonding bridge StoCrete TH 250. StoCrete TS 250 was applied to the wall areas of the basin using a wet spraying method. This method of working enabled the vertical surfaces to be worked on quickly and efficiently of the 800 square metre area. The StoCrete TG 154 screed mortar was applied on the 570 square metre floor area of the stormwater overflow basin.

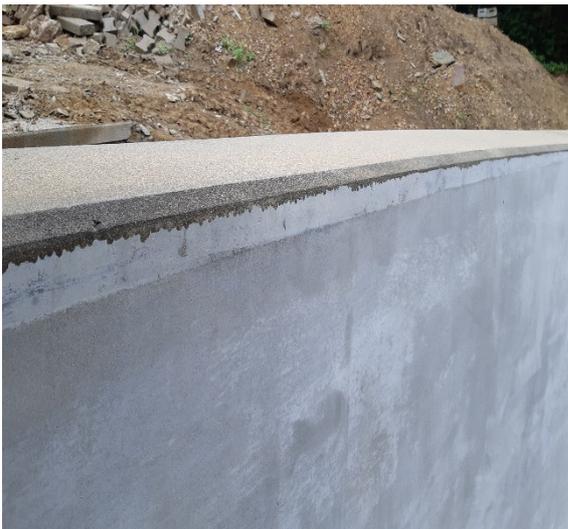
On the wall coping, the experts applied additionally a StoCretec surface protection system consisting of the EP primer StoCrete GH 205 and the EP sealing coat StoPox DV 100. To ensure that the wall coping was sufficiently slip-resistant, the primer was broadcast in excess using StoQuarz RF.
